Review of Investigation Report on the Flooding in
Sha Po Tsai Village, Tai Po on 22 July 2010

Professor Joseph Hun-wei Lee
Croucher Laboratory of Environmental Hydraulics
The University of Hong Kong

12 October 2010

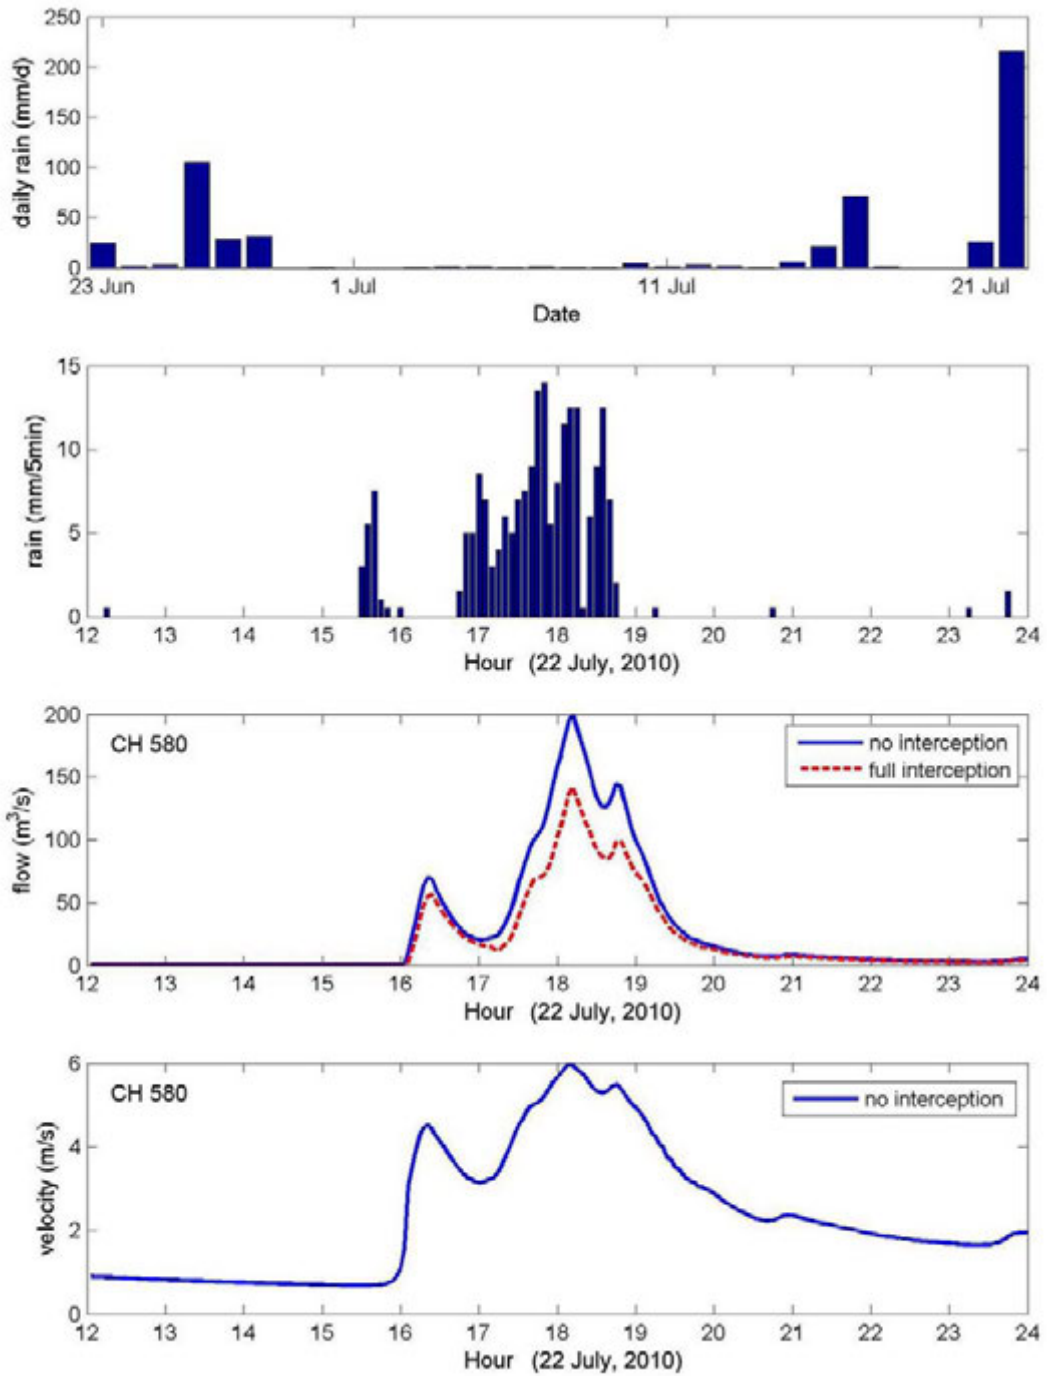
Figure A2 Observed rainfall and the predicted flow and velocity at Sha Po Tsai village (CH580) on 22 July 2010

Hydrological calculations under this Review using the calibrated MIKE-SHE model (simulating the physical processes of infiltration and overland flow, rather than assuming lumped empirical parameters) suggest that the maximum flow at the downstream end of Sha Po Tsai Village is of the order of $140 \text{ m}^3/\text{s}$, including discharge from air-regulated siphon of vortex intake, discharge from bottom rack intake spillway and catchment runoff downstream of WSD water supply intakes. In this calculation, a single channel of bottom width 18 m and top width 24 m is assumed for Sha Po Tsai (Appendix A).
